# Impact of Costs Related to International Roughness Index Variability on a Brazilian Runway

The functional quality of runways (RWY) is a critical factor for the safety and comfort of airport operations. One of the main indices used to assess this quality is the International Roughness Index (IRI). Maintaining IRI values within acceptable limits is essential to avoid operational problems, reduce aircraft maintenance costs, and ensure safety. In this context, the aim of this article is to analyze whether there is variability in the IRI with maintenance and rehabilitation (M&R) costs on a RWY. The research method used data provided by the National Agency for Civil Aviation (Agência Nacional de Aviação Civil [ANAC]) for the years 2020, 2021, and 2023, collected by a laser profilometer. The results show that the interventions carried out in 2020 reduced the IRI values in 2021, improving the pavement condition. However, an increase in the IRI values was observed in 2023, indicating the onset of deterioration. The financial analysis showed that the most expensive interventions occurred in 2020 due to the need for pavement reconstruction, while in 2021, costs were lower due to preventive

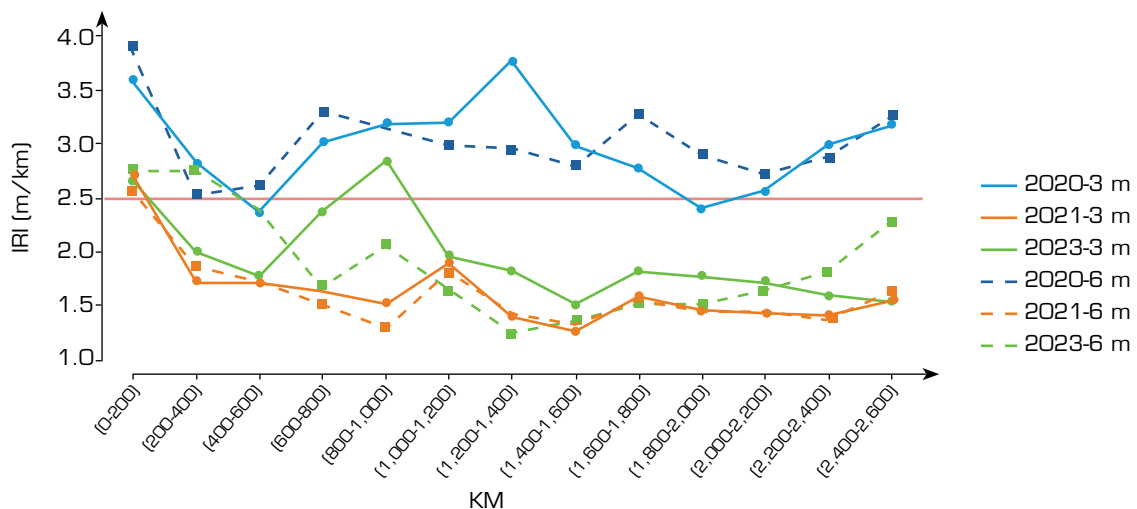
**Figure 1.** Line graph of the average IRI values on the right-hand side.

As demonstrated in Fig. 1, there is a clear variation in IRI along the RWY on the right-hand side. In 2020, the highest IRI peaks were observed, indicating greater unevenness in the roadway. In contrast, the 2021 data reveal a decline in longitudinal unevenness, manifesting as a decrease in IRI values and a concomitant enhancement in their stability. However, in 2023, the RWY demonstrated a deterioration in irregularity, particularly in the measurements at 3 meters. In both 2021 and 2023, measurements at 3 meters consistently exhibited higher values compared to those at 6 meters. However, a general tendency towards decrease was observed along the analyzed stretch.

In 2020, the majority of sections of the RWY, with the exception of two at 3 meters, exceeded the IRI limit value of 2.5 m/km (ANAC 2023), indicating a necessity for M&R. In 2021 and 2023, the majority of measurements fell below the established limit, with only sporadic instances of noncompliance observed in the [0-200] and [800-1,000] sections. These findings indicate a decline in the longitudinal irregularity of the RWY, in comparison to the data observed in 2020, thereby demonstrating adherence to the standards stipulated by ANAC. Although the highest IRI values observed over the years are concentrated in the first third and the aircraft touchdown zone, where the greatest impacts on the surface occur, it is important to note that this is not the only area with elevated IRI values. Figure 2 presents the IRI measurements at 3 and 6 meters for the years 2020, 2021, and 2023 on the left side of the RWY.

The analysis conducted in 2023 indicates an augmentation in the standard deviation across multiple segments, particularly at 6 meters on both sides of the RWY. These findings imply an escalating degree of variability between the IRI measurements of the RWY, particularly during the initial and medial phases of the RWY. It can be seen that the results in Table 4 corroborate the results in Table 3, where the same segments with longer measurement intervals have standard deviations above 0.5. Figure 1 shows measurements of 3 and 6 meters of IRI in the years 2020, 2021, and 2023 for the right side of the RWY.

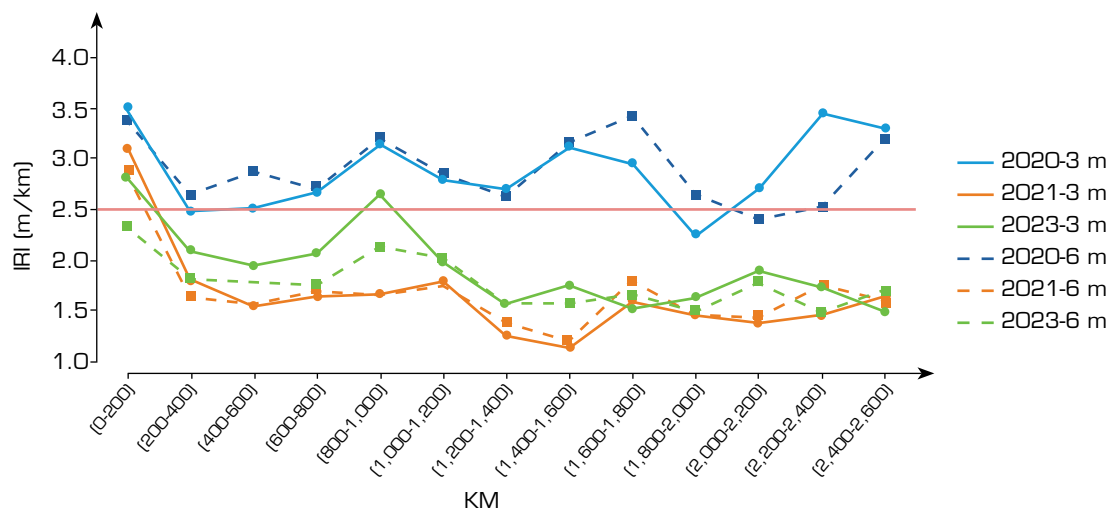
**Figure 2.** Line graph of the average IRI values on the left side.

As illustrated in Fig. 2, there is a demonstrable variation in IRI along the RWY on the left-hand side. In 2020, the highest IRI peaks were observed, indicating greater irregularity, especially at the beginning of the survey in the [0-200] segment, with only three sections not exceeding the 2.5 m/km limit. In 2021, a decline in longitudinal irregularity is evident, contrasting with a resurgence in IRI values in 2023, signifying a deterioration in RWY.

With the exception of 2023, measurements at 6 meters exhibited higher IRI values compared to measurements at 3 meters, while the reverse was observed on the right side. In 2021 and 2023, the majority of measurements were below the limit, indicating a reduction in longitudinal irregularity. This improvement was consistent with the right side of the RWY, suggesting a uniform pattern across the array. It is important to acknowledge that while the IRI values decreased in 2023, the potential for a resurgence to the 2020 levels persists in subsequent years in the absence of M&R. To calculate the M&R costs required for the RWY, each segment of the RWY was classified. Similar to Fig. 1, Fig.2 also shows elevated IRI values in the aircraft touchdown zone, although it is not the only region to record high IRI values. The classification of the functional condition of the RWY sections in relation to the IRI values is illustrated in Table 5, with consideration given to the criteria outlined in Table 1.
