# Feasibility Assessment of Unmanned Aerial Systems for Precision Approach Path Indicator Inspections: a Cost-Effective and Sustainable Alternative

## ABSTRACT

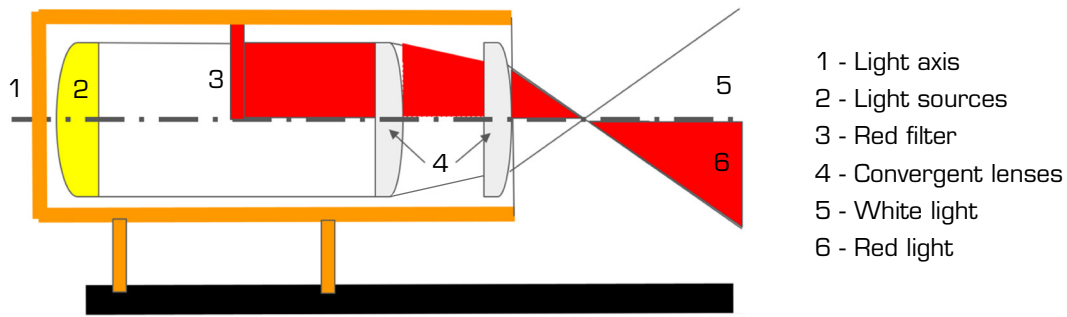
With the features of the light box as shown in Fig. 1, a series of four boxes are set at different angles, which are slightly above and below the nominal 3° approach path. In such an arrangement, a pilot in the approach phase can tell whether their rate of descent is more or less than what is required for landing safely. It also means that through a combination, precision approach path indicator (PAPI) lights provide critical feedback on whether the aircraft is on or off the glide slope and when it needs adjustment to maintain an ideal trajectory in descent.

**Figure 1.** Components of a PAPI light box.

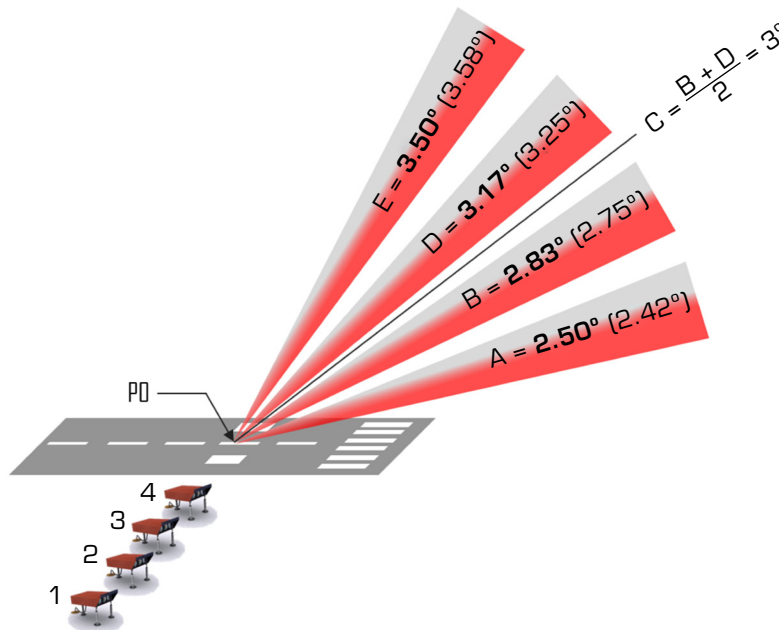
**Figure 2.** Precision approach path indicator (PAPI) light arrangement for a 3° approach path. The identified angles from the PO are the following: A: low transition; B: medium-low transition; C: nominal ramp; D: medium-high transition angle; and E: high transition. Angles in parentheses are standard values for ILS-connected installation and for large aircraft.

over the radio. The ground operator records the angle corresponding to the event and reads the data back to the flight crew for verification. In summary, the main goal of the inspection flight is to determine the inclination angle of each PAPI box, with the nominal  $3^\circ$  approach path values provided in Fig. 2.

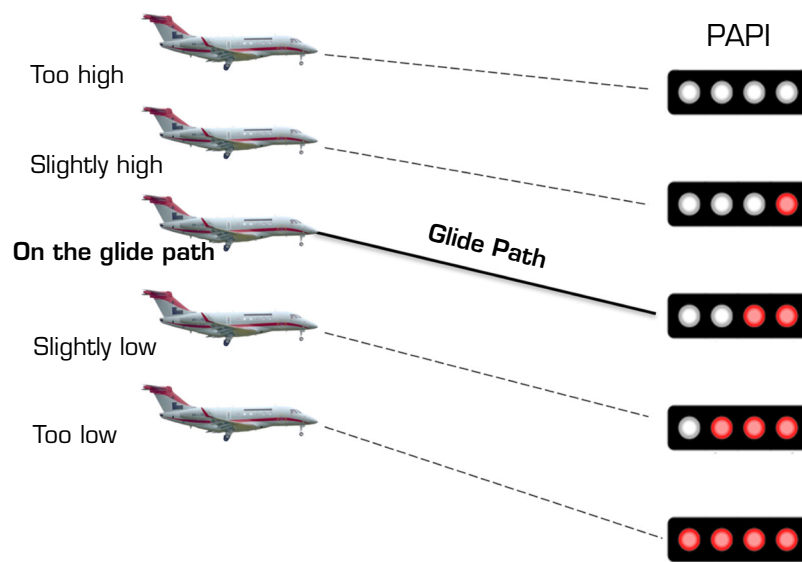
**Figure 3.** Precision approach path indicator (PAPI) light configuration indicating correct descent rate.

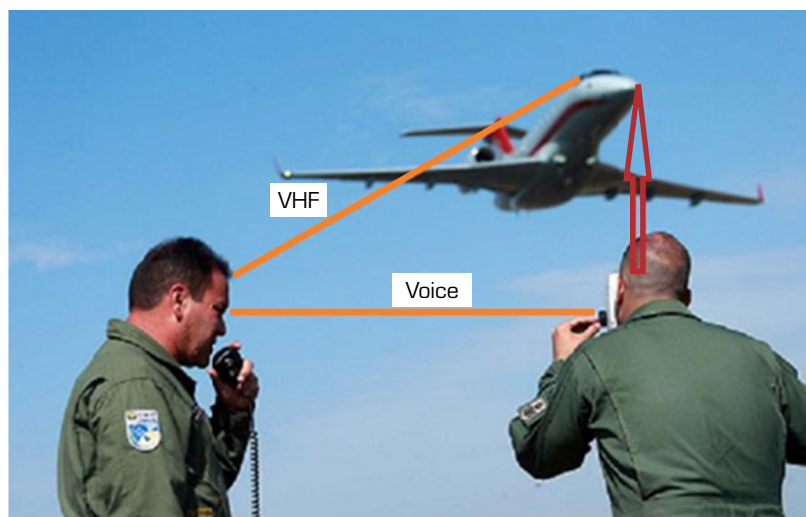
The traditional method for in-flight inspections of PAPI relies on the use of a theodolite to measure the angles of the PAPI light boxes. The execution of this requires close coordination between the aircraft crew and the ground inspection team operating the theodolite (Brasil 2023). The ground team positions the theodolite on a geodetically known position on the side of the runway, near the PAPI light boxes. The operator points the theodolite to the aircraft's nose (radome), while another team member, located nearby, contacts the flight crew on very high frequency (VHF) radio. Figure 4 depicts the process out of scale, meaning that the relative distance between the aircraft and the operators is much larger than shown in the figure.

**Figure 4.** Theodolite-based PAPI inspection method, where the ground operator aligns the theodolite with the aircraft's nose (radome), while a team member communicates with the flight crew via VHF radio for coordination.

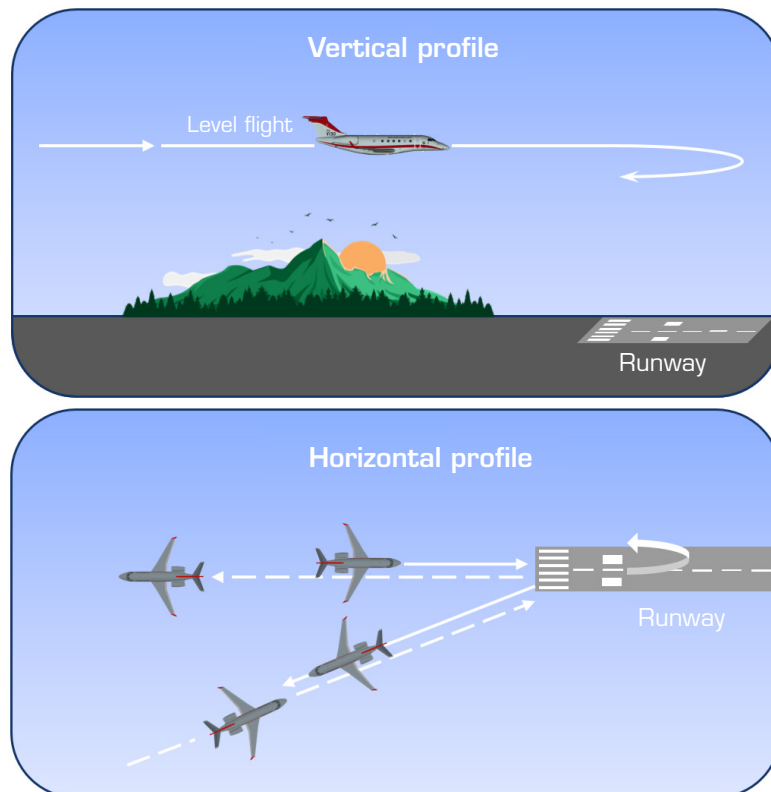
The Pattern 2 profile includes runs where the aircraft maintains a constant altitude while flying toward and away from the PAPI system from predefined points. In some cases, the flight path deviates laterally from the runway's extended centerline. This operational profile is illustrated in Fig. 5.

**Figure 5.** Flight profile Pattern 2 for vertical inspection.

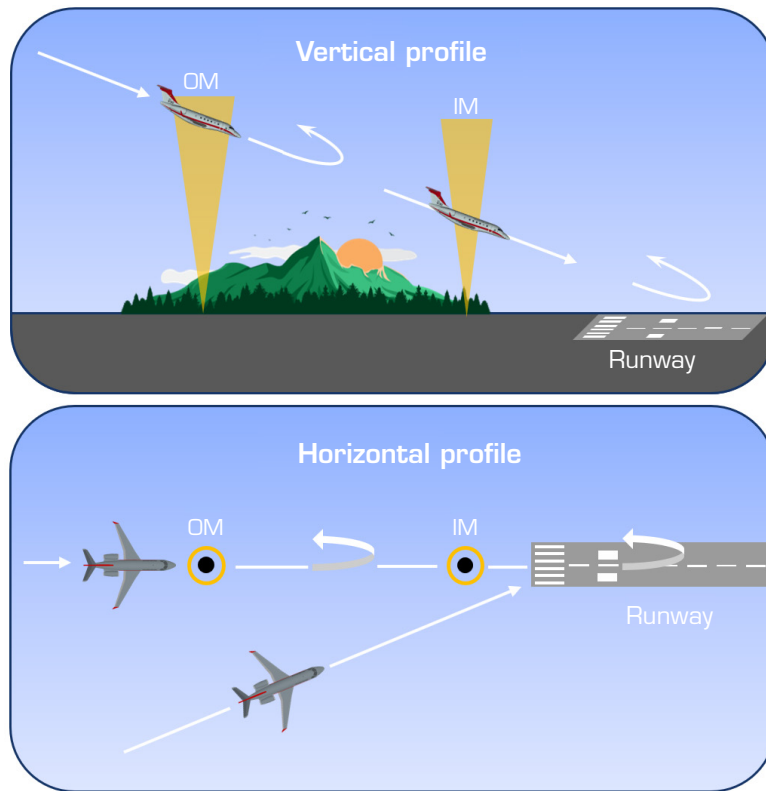
The Pattern 3 profile type encompasses approach flights directed towards the runway, which follow a go-around maneuver slightly beyond the outer marker (OM) or over the threshold, typically deviating laterally from the extended runway centerline. This profile type is illustrated in Fig. 6.

**Figure 6.** Pattern 3 run profile with go-around maneuvers. IM = inner marker.

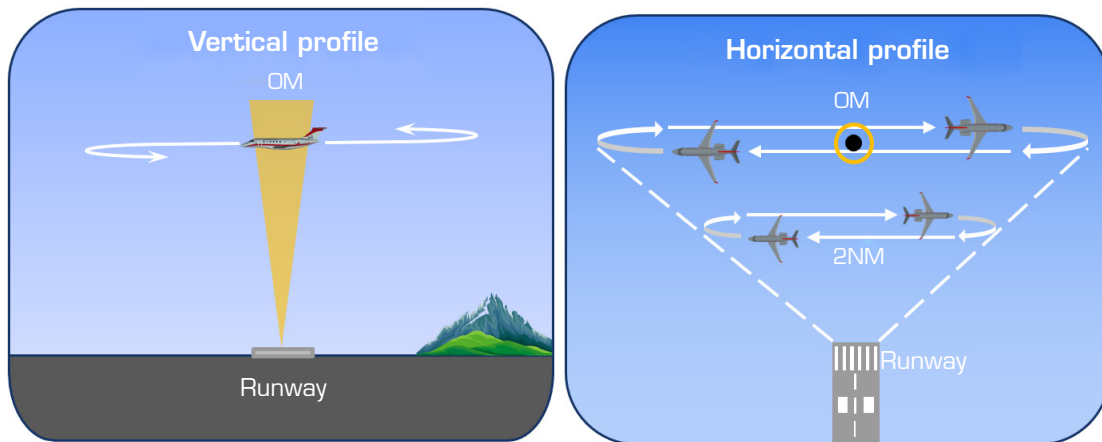
Pattern 4 runs are performed parallel to the runway approach axis, crossing the OM at a specified altitude. This pattern facilitates an angular inspection extending up to 45 degrees on either side of the extended runway axis. Figure 7 depicts this profile, where 2 NM indicates a two-nautical-mile distance.

**Figure 7.** Flight profile for Pattern 4, horizontal sweep.

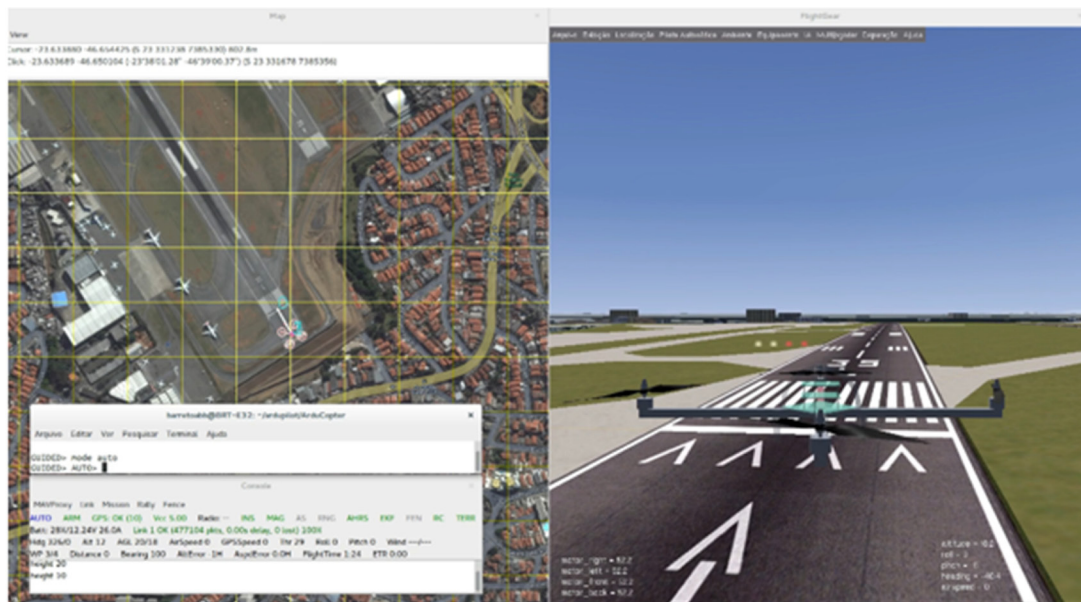
Before the experimental trials, a software-in-the-loop simulator was developed to analyze possible flight profiles. The operation of the UAS was planned to be conducted about 300 meters in front of the PAPI system and over the runway threshold. The simulator generated estimates of transition heights and lateral displacements required for the inspection process. Figure 8 shows the simulator interface. The left window gives a top-down view and pilot control panel; the right window provides a 3D view of the inspection scenario.

**Figure 8.** Unmanned aerial systems (UAS)-based PAPI inspection simulator interface.

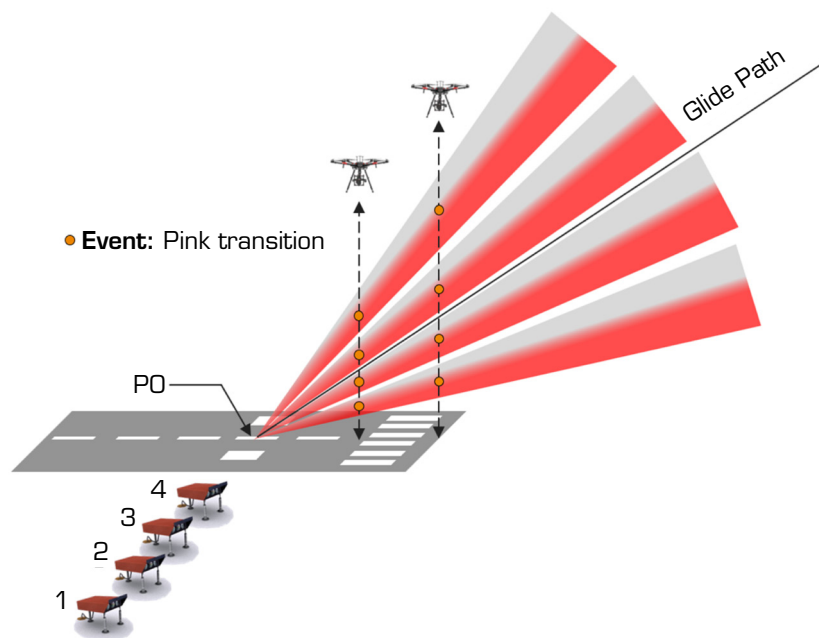
The vertical scanning method involves conducting flights upwards and downwards to capture all the PAPI light transitions, as shown in Fig. 9. From the coordinates of the point of origin (PO) and coordinates of the UAS, given by the RTK system, exactly in the transition position, the inclination for each PAPI box is estimated. To improve the detection of the transition by the optic system, a blue optical filter was used on the camera to enhance the visibility.

**Figure 9.** Vertical scanning method for descent angle verification.

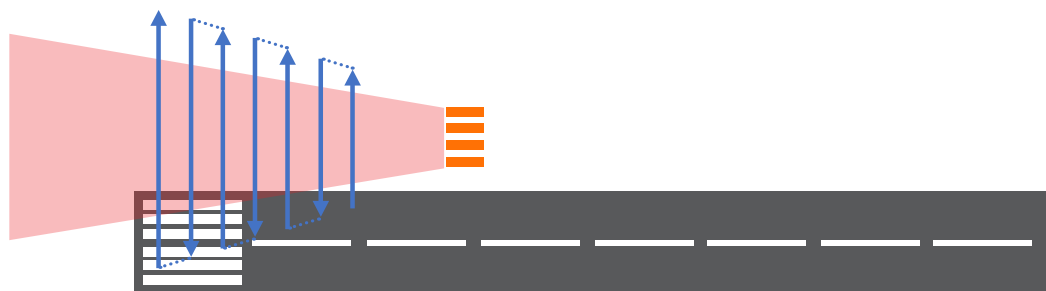
To evaluate the horizontal coverage of the PAPI, two distinct methodologies can be employed. The joint scanning (Figs. 10 and 11) involves moving the UAS parallel to the alignment of the PAPI boxes. During this process, two key events are recorded:

**Figure 10.** Illustration of incremental horizontal scanning showing the UAS moving laterally to the initial position.

To ensure the accuracy of the data collected, the UAS is progressively flown further away from the system, as illustrated in Fig. 10. It is recommended that this procedure be repeated at least seven times to minimize measurement errors and establish a reliable average.

The objective is to determine the angular coverage of the PAPI, indicated in magenta in Fig. 10. Notably, this coverage should be assessed when all lights are visible, meaning that consideration must be given to the point at which the opposite box's light first becomes visible.

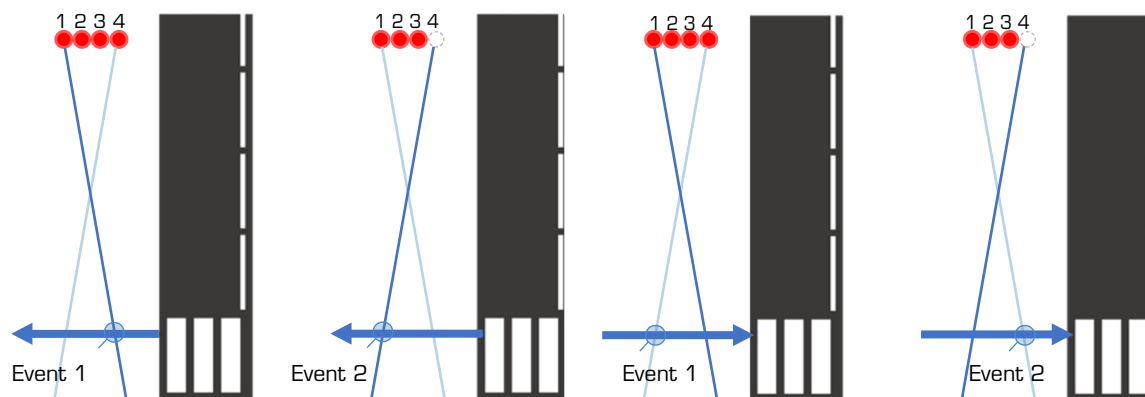
**Figure 11.** Events of incremental horizontal scanning: instant when all lights are turned on (Event 1) and first light is switched off (Event 2).

Event 1, when all lights in boxes 1 through 4 are illuminated, and Event 2, when the light in box 1 turns off. The UAS is then flown until all lights are extinguished, resetting the system for the next measurement.

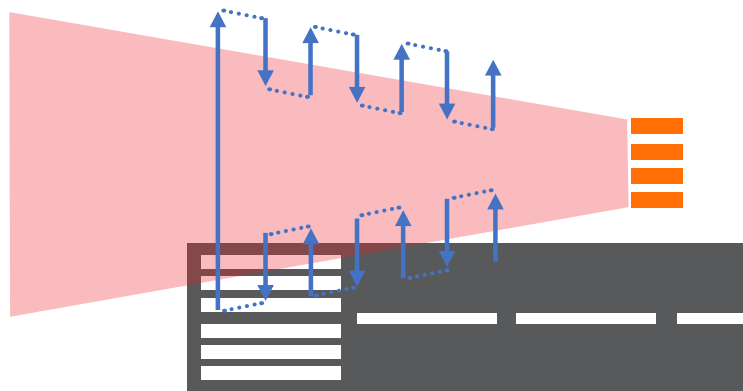
In turn, the individual box scanning involves moving the UAS parallel to the alignment of the PAPI boxes, with an initial focus on box 4, observing its lamp turning on and off (Figs. 12 and 13). After collecting data from box 4, the process was repeated for box 1. This method is useful when dealing with differing lighting conditions, or when consistent data is not obtainable using the joint scanning method.

**Figure 12.** Lateral-horizontal incremental scanning illustration with individual analysis of light boxes 1 and 4.

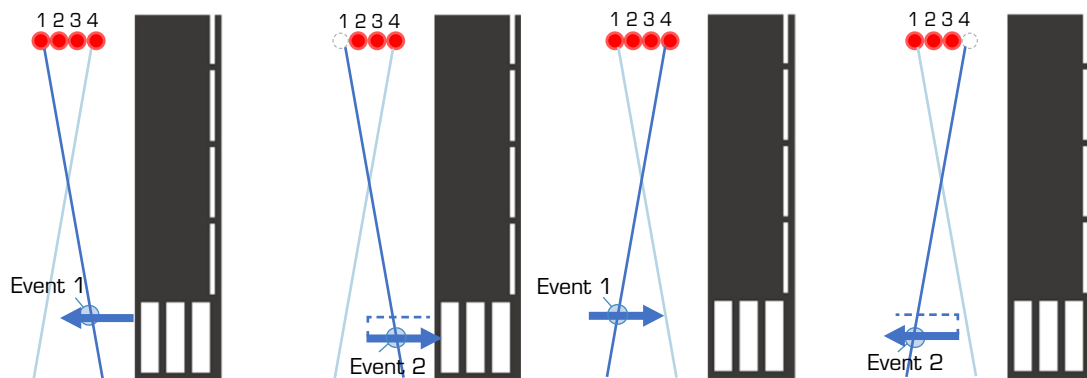
This process places the UAS at the location where all the lights are off. The UAS is then moved laterally until the light on the targeted box, either 1 or 4, turns on. Then the UAS moves further away from the PAPI and is displaced in the opposite direction until the light goes off. The process is repeated a number of times for the purpose of ensuring precision of measurement.

**Figure 13.** Events of incremental horizontal scanning: instant when all lights are turned on (Event 1) and first light is switched off (Event 2).

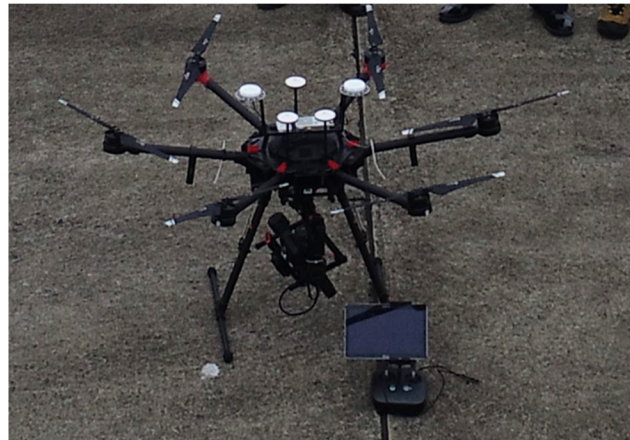
Data collection was performed using the DJI Matrice 600 PRO (DJI 2020), shown in Fig. 14, which is equipped with RTK positioning, assuring high-precision 3D location accuracy. The camera mounted on the drone was a Nikon D3100, using the original gimbal system to capture images in high resolution. Table 1 specifies in detail the technical specifications of the UAS used in this research work.

**Figure 14.** DJI Matrice 600 PRO used during this study.

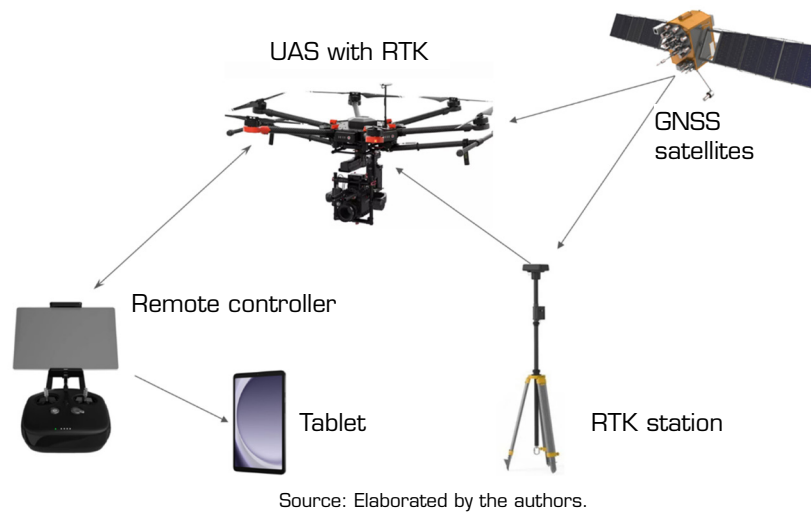
**Figure 15.** Real-time kinematic (RTK) positioning system used for precise geolocation.

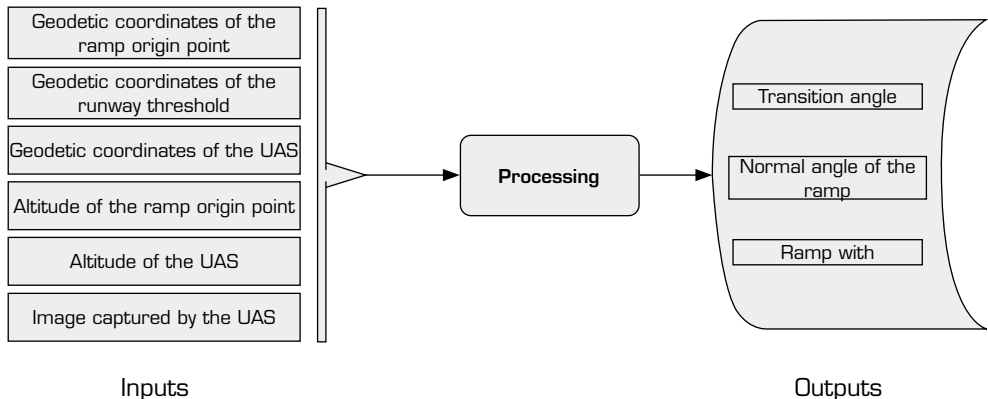
During the horizontal scanning process, the UAS flew at a constant height in a sideways motion in such a way that it covered the complete horizontal beam spread of the PAPI lights. The UAS was initially positioned to view all red lights and moved laterally in progressive steps until the lights were not visible. The instant that all lights were on and the instant the first light went out were noted. Figure 17 shows a diagram of the processing chain for horizontal scanning.

**Figure 17.** Horizontal scanning processing diagram.

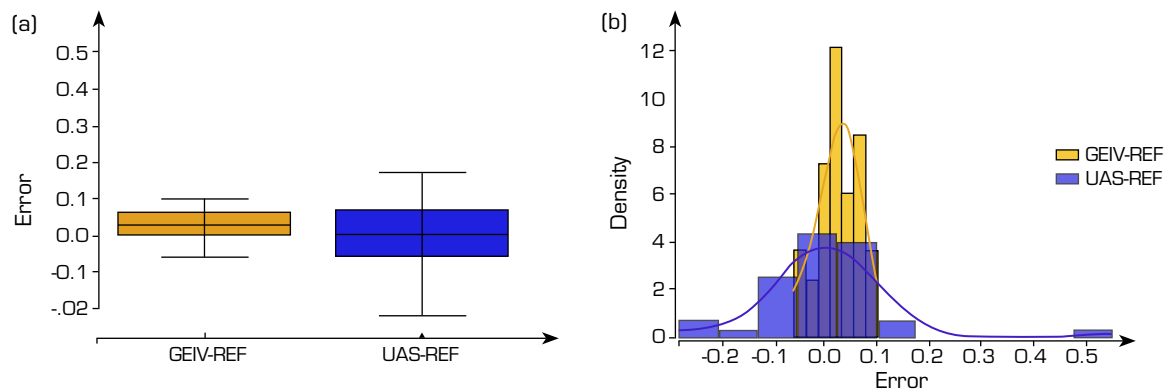
**Figure 18.** Boxplot (a) and histogram (b) of measurement deviations.

In this work,  $\alpha = 0.01$ , hence  $c(\alpha) = 1.63$ . It was found that  $D_{UG} = 0.3056$  and  $D_{crit} = 0.3842$ , with corresponding p-value = 0.0690. Since  $D_{UG}$  did not exceed  $D_{crit}$  and the p-value was higher than the critical significance level, the null hypothesis of identically distributed both datasets could not be rejected.
